Code Talkers

Cross Slope—It's Not About Skiing

by Mark A. Goska, AIA, MBA

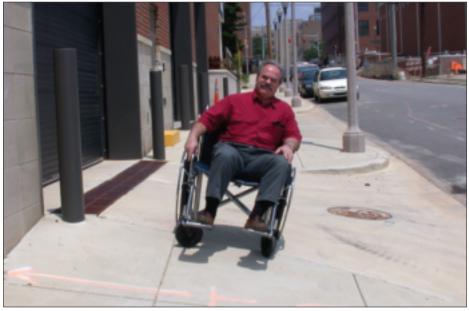
This cross slope is too steep and is an example of what happens when finish grades and spot elevations are not checked and confirmed by the design professional during construction.

There are many reasons these problems with cross slope occur: for example, if the natural terrain of the site has a slope greater than 1:50, or if the design professional does not include cross slope requirements in their sidewalk design, or if the contractor fails to shoot the grades before installing the walks to make sure that the slope is within ADA compliance. Another reason for this oversight that many design professionals stop the scope of their work at the property

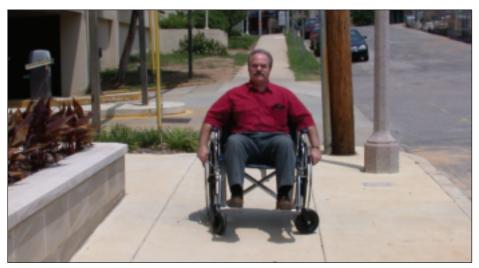
This cross slope is within the requirements of ADA.
