By Anita Blumenthal

# CARING FOR HISTORIC BUILDINGS

## Preserving a Heritage, Renovating for the Future

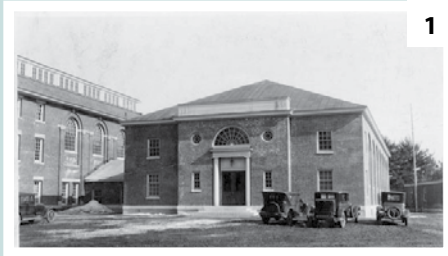
1

Original Curtis Pool Exterior (1928)

Old armories and outgrown gymnasiums and libraries are prime structures for repurposing. At **Bowdoin College**, Brunswick, Maine, the Curtis Pool (1928) closed in 1986. Donald Borkowski, director of capital projects, explains that, in 2007, “the interior was gutted right down to structure and put together as a recital hall with world-class acoustics.” Even when buildings are not immediately repurposed, they are often being preserved for eventual use, rather than demolished.

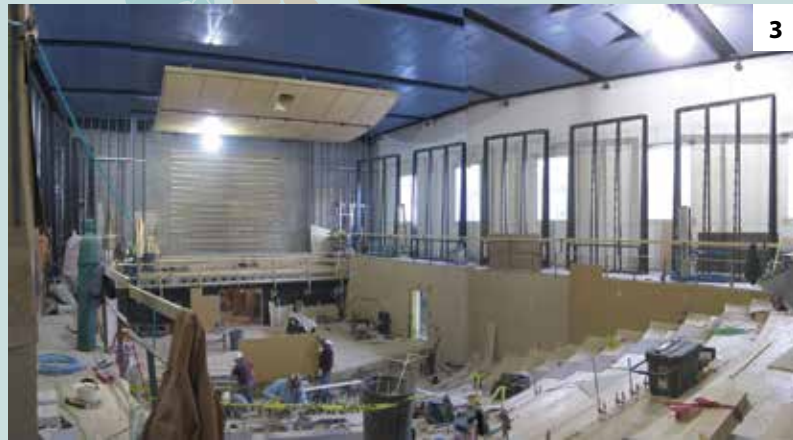
3

In 2007, the pool was repurposed to a Recital Hall.

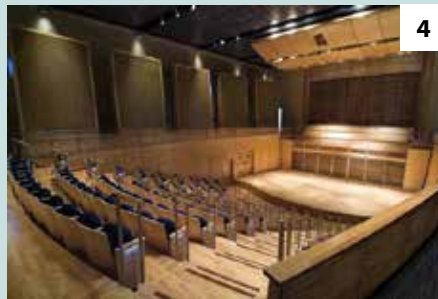
4

Finished Recital Hall.

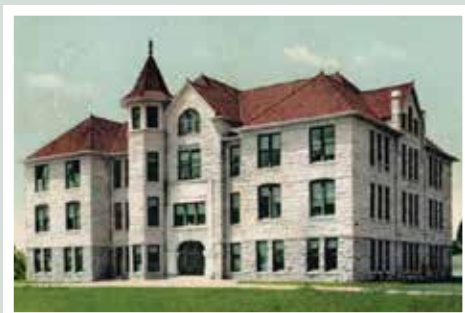
Historical Image of OSU's Furman Hall, 1902.

**Oregon State University**, Corvallis, took a different approach to “taking the skin off” of Furman Hall (1902), one of the oldest buildings on campus, says David Dodson, university land use planning manager. The façade had been sandstone, but the grain was such that water had penetrated for years. In fact, there was fencing around the building to keep people away because stones at the top threatened to topple. In renovating the building, he says, “we did not replace the huge 600 lb. stones. Instead, we put in a new structural wall and added a thin façade of limestone that replicated the original sandstone.”

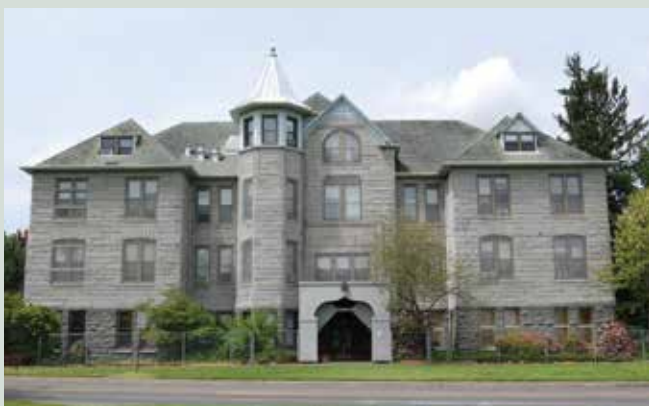
As the condition of the building deteriorated, a fence was erected to protect passersby from possibly unstable masonry.

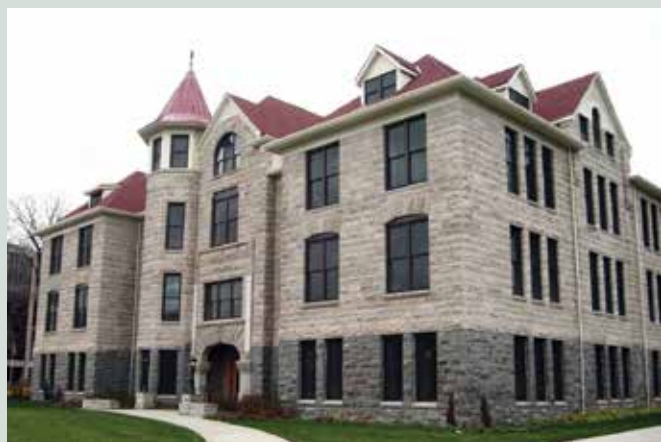
The building was renewed with a facade of limestone that recreates the original look.

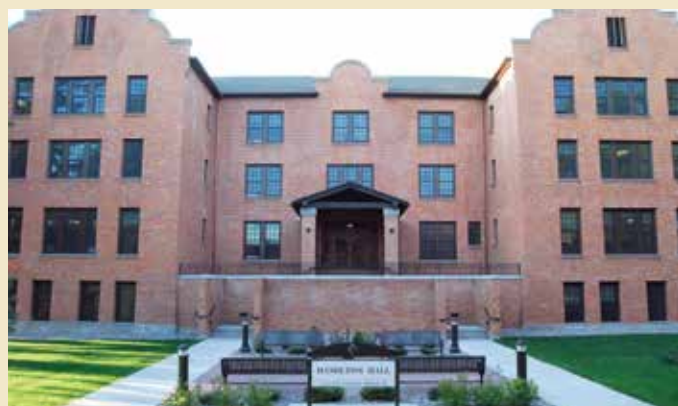
Hamilton Hall, MSU 2012, the renovated main entrance that again resembles the original main entrance, enhanced with code-required railing to the landings.

At **Montana State University**, Bozeman, an interior and exterior renovation of Mission Revival-style Hamilton Hall (1910) did not seek to replicate the original materials. “Materials do not match exactly,” explains Associate University Planner Victoria Drummond. “The new material should respect the original design. And although it is obviously new, it is related to the minds and hands of the original craftsmen,” she says. “The intention is to be respectful, show the connection, and be proud of the technologically enhanced materials we have now. For example, the original flooring in many of the early 1900s buildings is Italian terrazzo, which was created by a family of craftsmen 100 years ago. We don’t want to try and duplicate

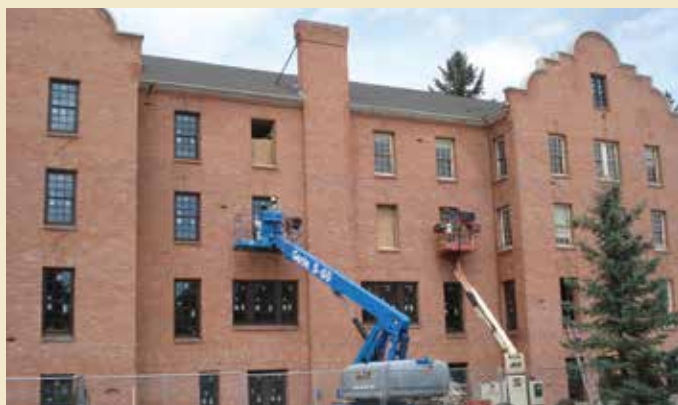
In 2009, the wood single-pane glass windows were replaced with replica double sash, multi-light dual pane windows, achieving energy improvement and historic preservation. The color of the trim was also researched and returned to its original dark color. This photo shows both the original and replacement windows.

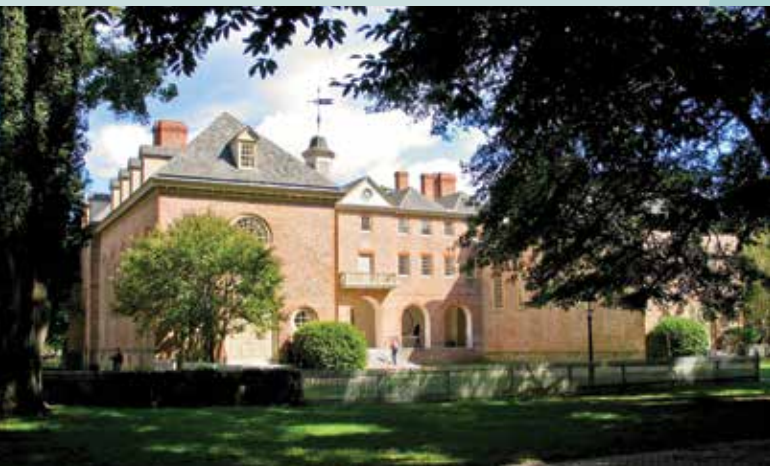
The Sir Christopher Wren Building at the College of William & Mary in Virginia is the oldest college building in the United States and the oldest of the restored public buildings in Williamsburg. In the course of its history, the Wren Building has been gutted by fire three times—in 1705, 1859, and 1862. Each time the interior of the structure was rebuilt.

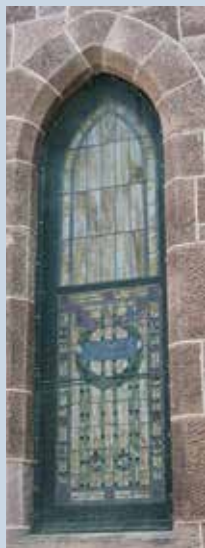
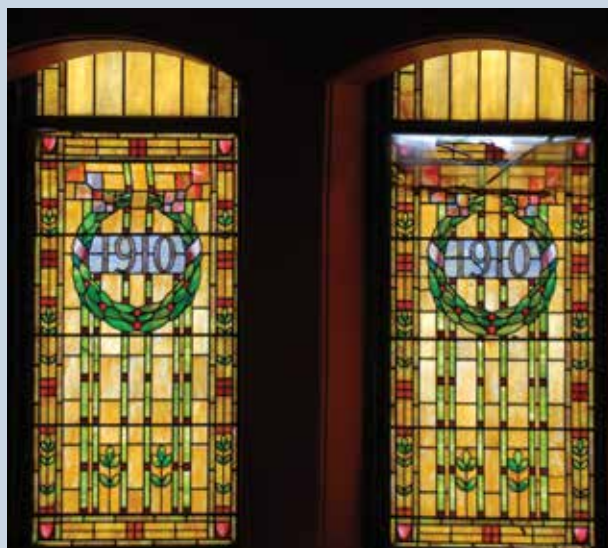
Kirkpatrick Chapel (1872) at Rutgers received three stained glass windows by Louis Comfort Tiffany during its 1916 renovation.

Sometimes new technology comes to the rescue. When Kirkpatrick Chapel (1872) at Rutgers was renovated in 1916, it received new stained glass windows, including three created by Louis Comfort Tiffany. Rutgers Architect Elizabeth Reeves says that restoring the windows in the past few years required a qualified preservation architect, a stained glass window consultant, and an expert artisan who could construct the same type of lead coming as the original, along with making many other re-

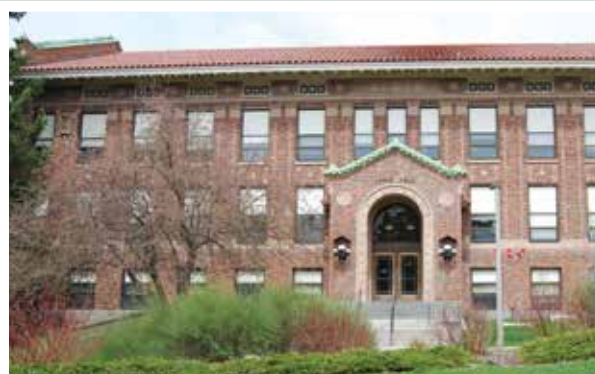
Lewis Hall, MSU, 2014 main entry with new green roof tiles that replaced the metal standing seam roofing installed mid-century, and the restored terra cotta medallions and decorative arch surrounding the main entry.

At Montana State University, the original front and most elegant entrance of Lewis Hall (1923) has been preserved, with the terra cotta arch and medallions restored in an award-winning program. But it is part of a complex of buildings, including research labs, which need to be connected to one another. Those connections are on other facades.

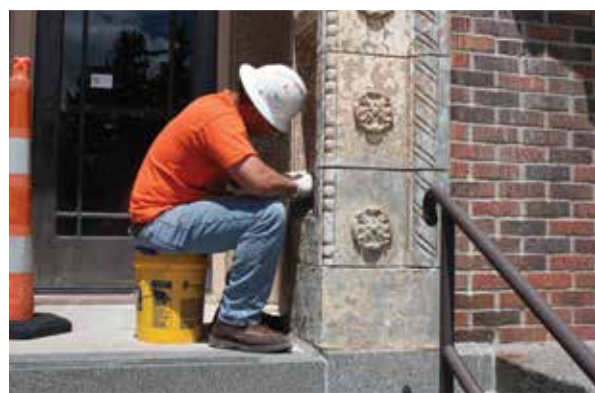
Lewis Hall, MSU, 2013 during restoration of the terra cotta architectural elements.

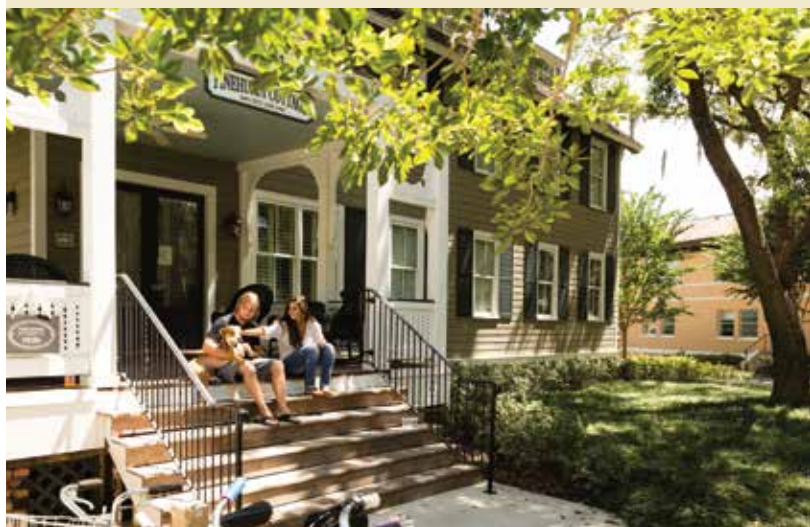
Pinehurst Cottage Today. Last of the original 1885-86 wooden buildings.  
PHOTO COURTESY OF SCOTT COOK FOR ROLLINS COLLEGE

A few years ago, Pinehurst was renovated and got new siding—yet again—using the correct cypress boards. “It already looks bad,” Bitikofer admits, adding that next time, they hope to replace it with a visually consistent cementitious board with a profile like clapboard. “You have to find the sweet spot between historical and pragmatic,” he says.

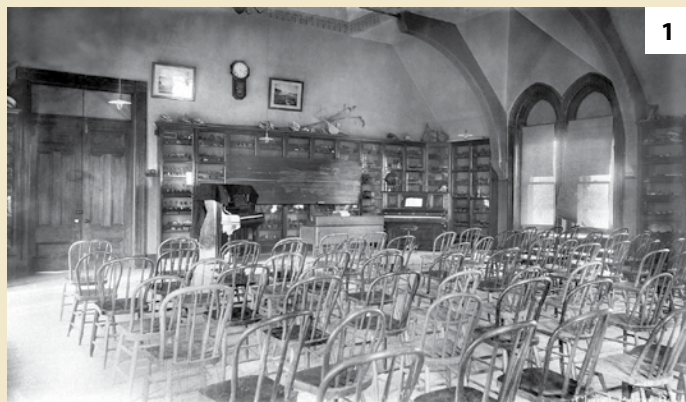
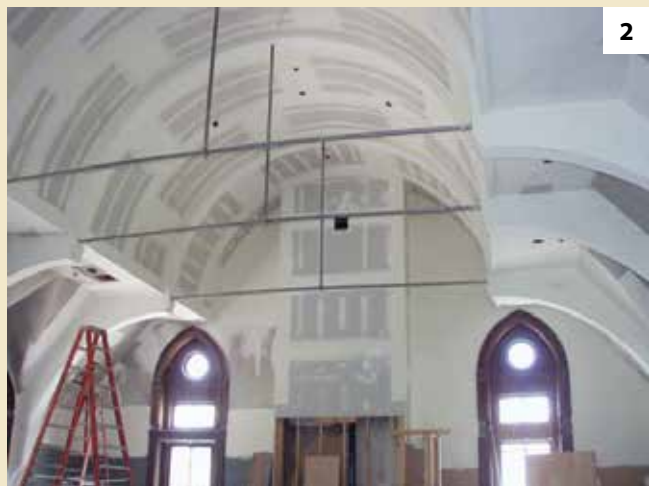
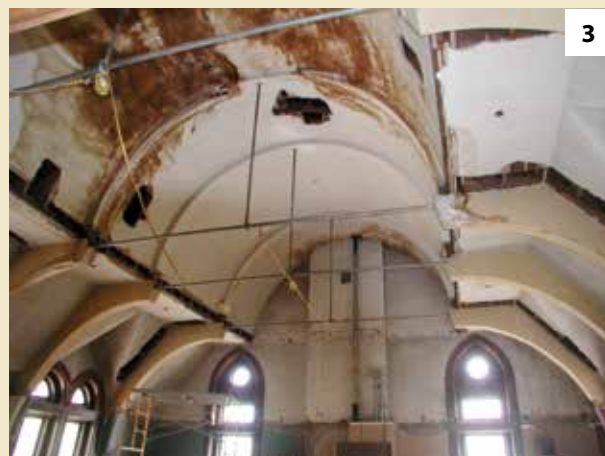
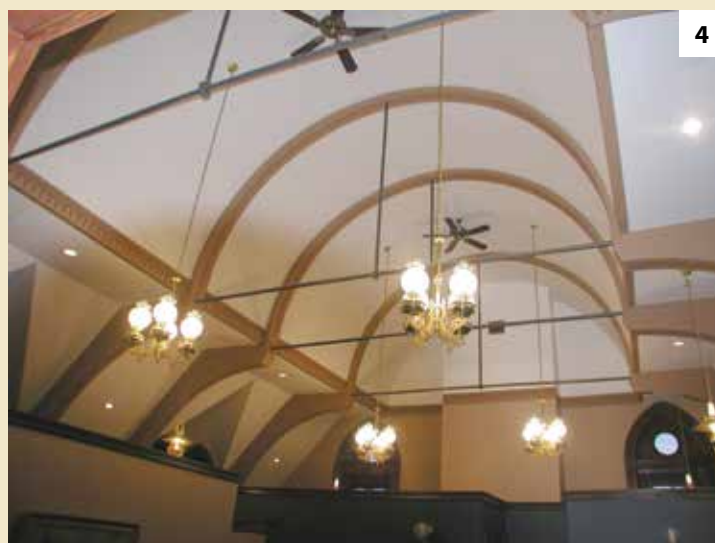
### CUTLER HALL—COLORADO COLLEGE

Cutler Hall (1880), before, then with ceiling removed and vaulted ceiling revealed, then renovated.

Assuming that acoustical tiles were installed for noise control, Colorado College was careful to preserve the goal as it changed the solution. When they opened up the ceilings at Cutler Hall (1880) and uncovered vaulting arches, they knew that the staff still needed viable offices. So they applied acoustic plaster to muffle sounds.

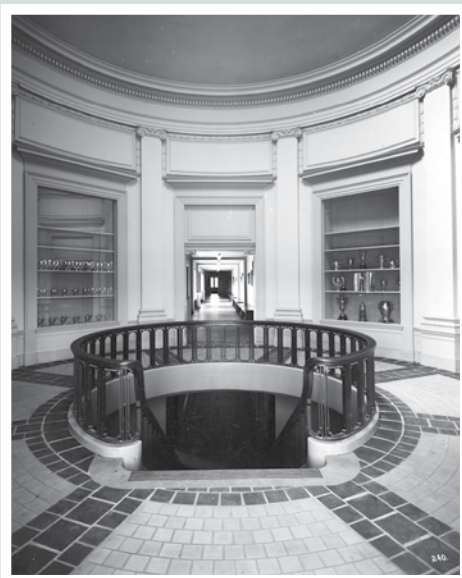
**Cossitt Hall Rotunda:** “The oak and steel guard railing around the Cossitt rotunda had to be 42 inches in height to meet code, so we added a similar oak hand rail above the original railing without disturbing the original,” explains Campus Planner George Eckhardt. “We also had to infill the vertical metal balusters to meet the 4-inch maximum spacing code, which was done without impacting the original metal balusters.”

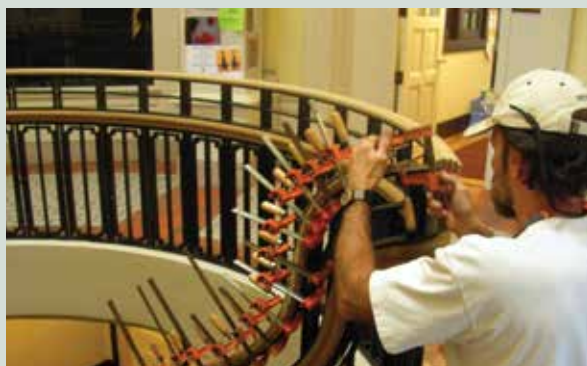
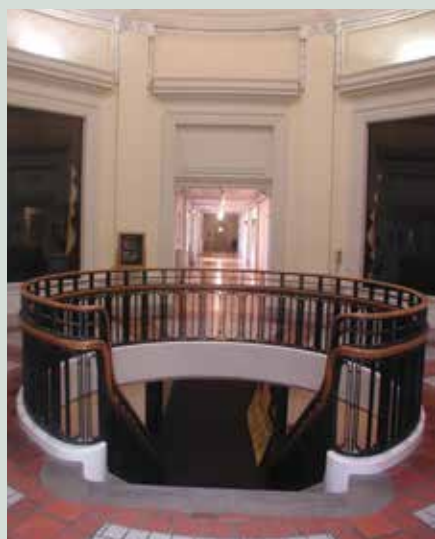
“Likewise,” says Eckhardt, “the connected oak stair hand railing had to be 36 inches above the steps so a continuous hand railing was added above the original oak rail. The continuous connection does not exactly meet code, but maintaining the significant historic contour feature of the oak railing was an important detail.”

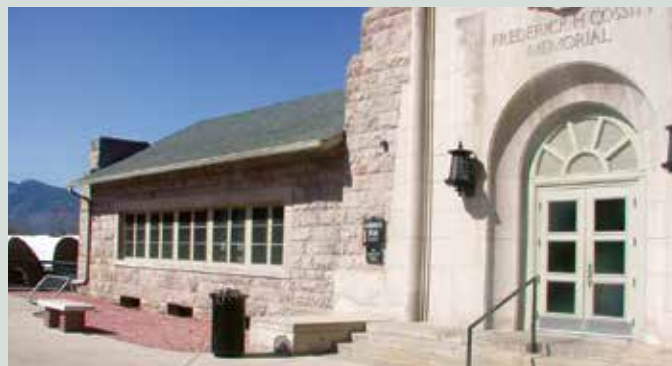
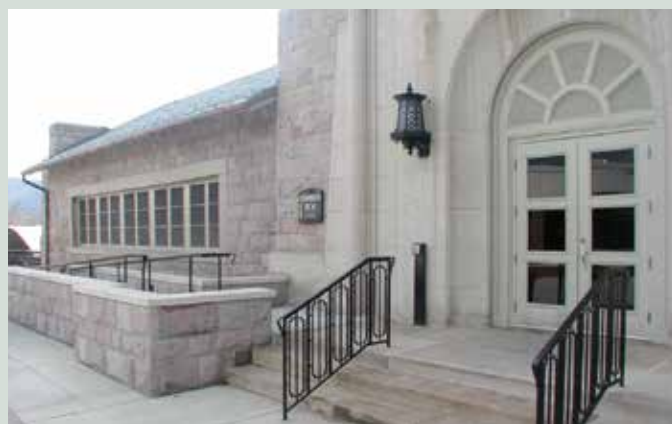
**Cossitt Hall Exterior:** The exterior photos show how well the new ADA access ramp blends in with the exterior stone walls, using the exact same volcanic ash rhyolite stone used in construction the building in 1914.

Today, there are subtler—and more expensive—approaches. For example, at Colorado College’s Cossitt Hall (1914), the ramp fits in seamlessly, made of the exact volcanic rhyolite stone of the building.

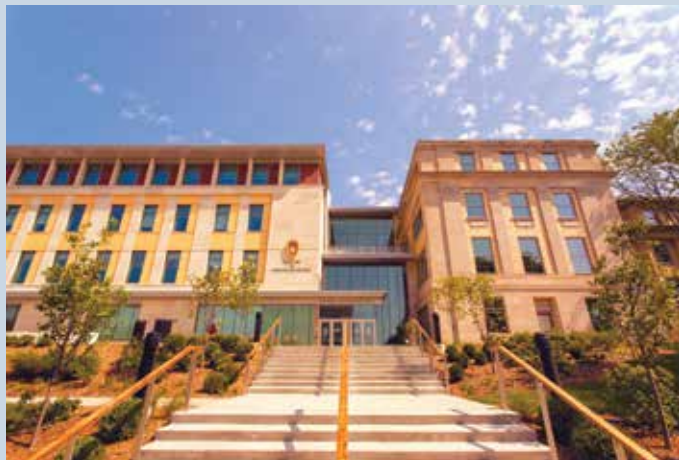
At University of Wisconsin-Madison's Nancy Nicholas Hall, a "hyphen" connects the old and new buildings and also creates space. The new building recognizes the design template and is respectful of the old building, but does not replicate it.

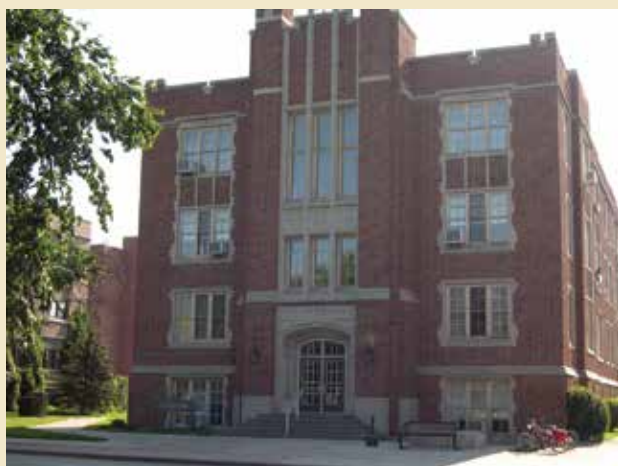
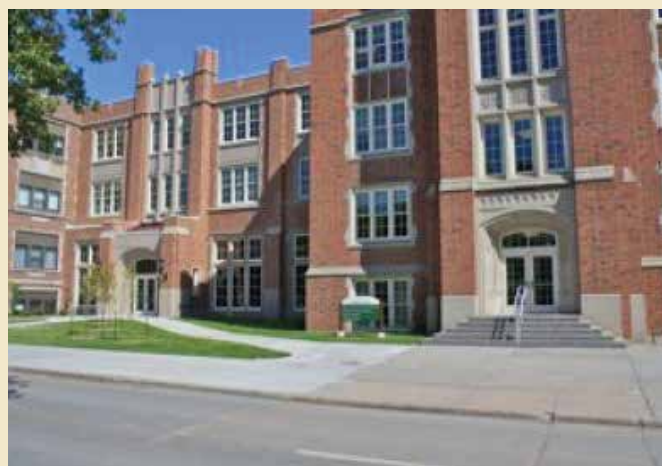
At the University of North Dakota, the renovated Education Building (1954) is joined seamlessly by the New Education Annex, built with the same materials and reflecting the signature architecture of the university. The project was the first higher education facility in the state to earn the LEED Silver designation. The older building is on the National Register of Historic Places.

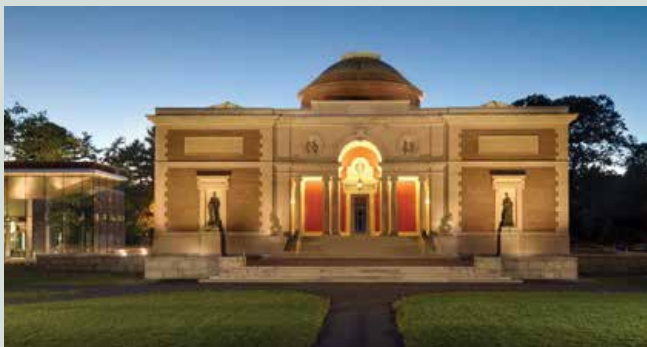
**Creating Access:** When the Maine Historic Preservation Commission forbade alteration of the grand main stairway during renovation, Bowdoin built a separate bronze and glass pavilion with elevator and staircase going down to the museum's lower level.

At Bowdoin, where the art museum underwent a \$20 million renovation, the ADA problem was that the first floor was well above grade, approached by a sweeping staircase. Although the project architects proposed altering the staircase, the Maine Historic Preservation Commission said it could not alter the view of the building. The solution, Borkowski explains, "was to build a bronze and glass pavilion separated from the building but acting as the new entrance to it." The pavilion contains an elevator and stairs going down, depositing people at the lower level of museum; they can proceed to upper floors from there.

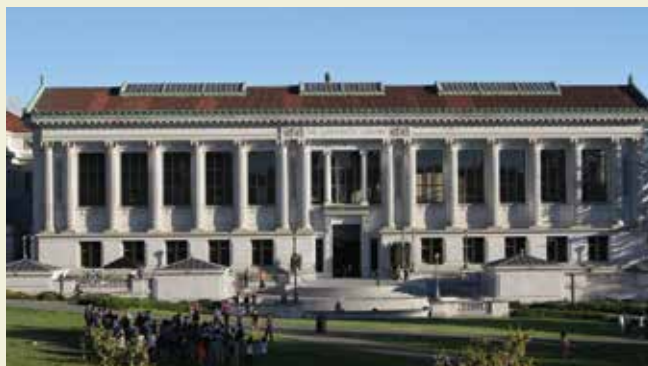
This Classical Revival building was completed in 1911. The gilded, sculpted barrel vault ceiling of the library's reading room was long hidden by a dropped ceiling.

For decades, the reading room at Doe Memorial Library (1911) at the University of California, Berkeley had a dropped ceiling. They opened it up and uncovered a gilded, sculpted, 45-foot-high coffered elliptical barrel-vault ceiling. Berkeley's LeConte Hall (1925), "originally had a large open hall, big skylight, excellent ventilation, and natural light," says Marthinsen, "but it had been covered and become a warren of offices." Now it's an open grad student area, with the skylight uncovered. However, lest we wax too nostalgic about old buildings, she points out that, constructed originally as a physics building, LeConte Hall had no ladies' room because it was assumed that

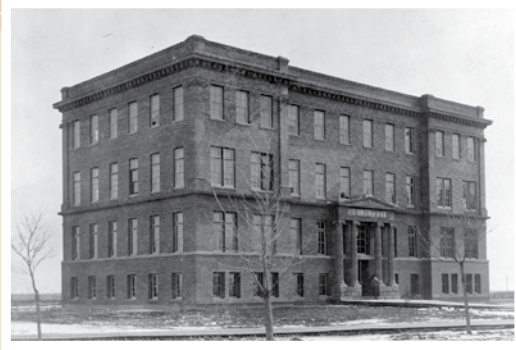
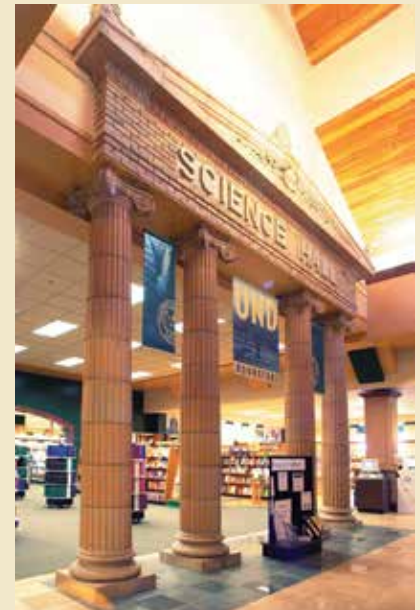
Original University of North Dakota Science Hall and the North Dakota Bookstore. The Science Hall was demolished in 1999 and the pillars were reused inside the bookstore in 2000.

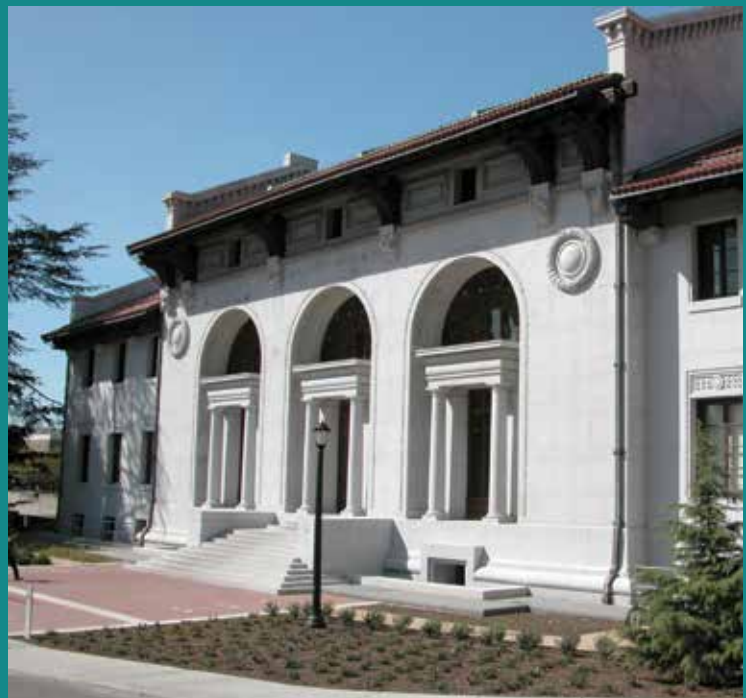
UC Berkeley’s Hearst Memorial Mining Building, after renovation.

Seismic strengthening is in building renovations on many campuses, but few projects have been as dramatic as that of UC Berkeley’s Hearst Memorial Mining Building (1907), a gem of a Beaux Arts building that lies 800 feet west of the Hayward Fault. By 1997, it had become so seismically poor and generally rundown as to be nearly unusable. The \$90.6 million renovation and expansion including a seismic retrofit that cut the granite four-story building free from its foundations, lifted it up, and installed a base isolation system of 134 composite steel and rubber bearings. The 60-million-pound building was lowered onto the isolators, which allow it to move 28 inches in any horizontal direction in an earthquake. (The base isolation technology had been pioneered by Berkeley engineers.) Today, the original exterior and a number of original interior components—such as three dome skylights above herringbone-tiled vaulting—remain intact. The building is home to the Department of Materials Science and Engineering. (source: UC media relations)
