The University of Texas Sewer Rehab:

Using Trenchless Technologies

by Leonard Friesenhahn, P.E.

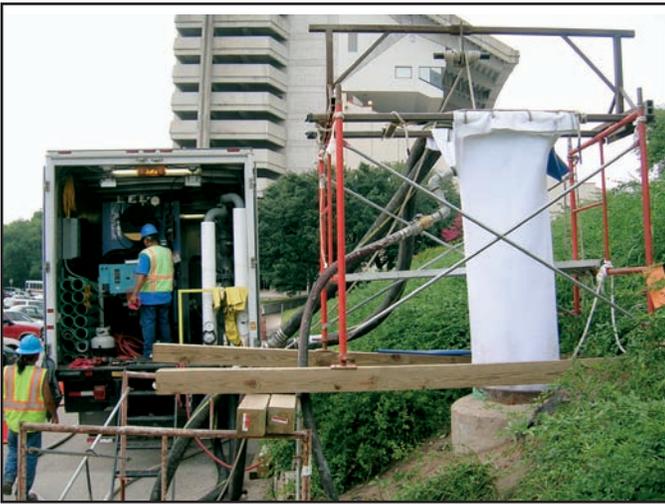
Sewer liner (sock) at manhole. Black hoses circulate hot water to cure resin.

epoxy-impregnated felt tube or "sock" that is inverted into the host pipe to form a pipe-within-a-pipe. A water column is the driving force for the inversion process. The water pressure both inverts the sock into the sewer and expands it against the inside of the existing pipe. When the sock is in place, the water in the sock is circulated through a boiler and heated to 180 degrees Fahrenheit. Circulation at this temperature is maintained for a calculated amount of time, based on the size and length of the sock, to cure the epoxy resin. The curing time can range from one to eight hours or more once the curing temperature has been reached. Once cured, the sock becomes a solid, impermeable pipe-within-a-pipe. The sock ends are manually cut out at the manholes and the taps are restored by a special TV-guided robotic hole saw.

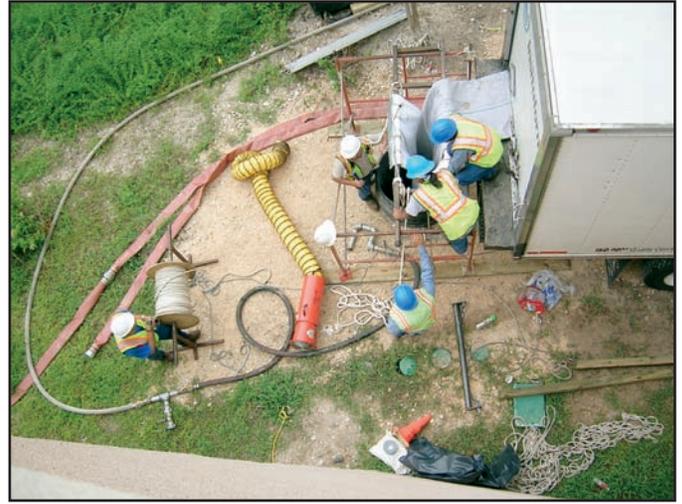
Workers feed epoxy-saturated 'sock' from refrigerator truck into manhole. Cold prevents resin from hardening prematurely.

Since the access manholes are located in narrow, busy streets, the project was scheduled for the semester break between the summer and fall sessions when the student population was at a minimum. The contractor mobilized for the five-day project with a refrigerated truck carrying all of the wet-out liners for the project, a boiler truck for heating and circulating water to cure the inverted liners, bypass pumps, hoses, support equipment, and an experienced crew.

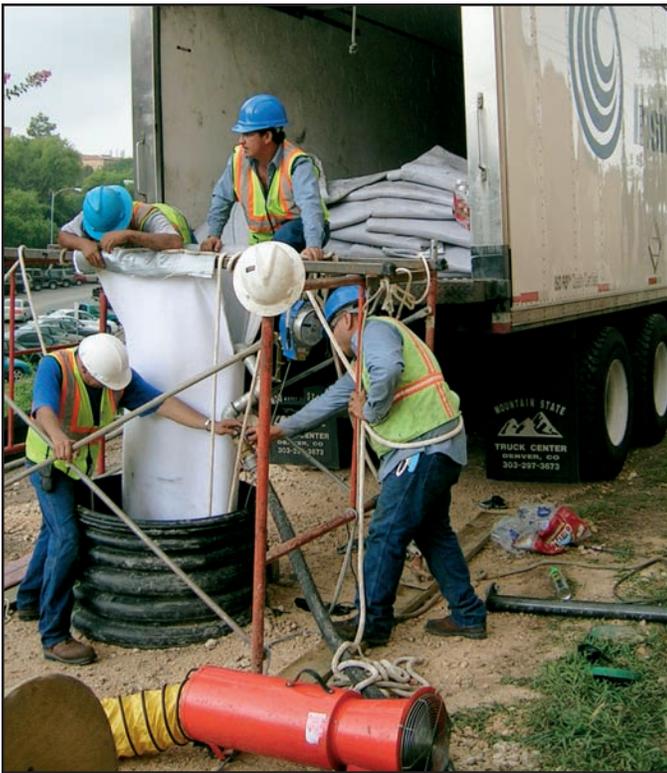
Workers feed epoxy-saturated 'sock' into manhole.
